**Milton Abbot Grouped Parish Council  
Retaining wall, Milton Abbot**

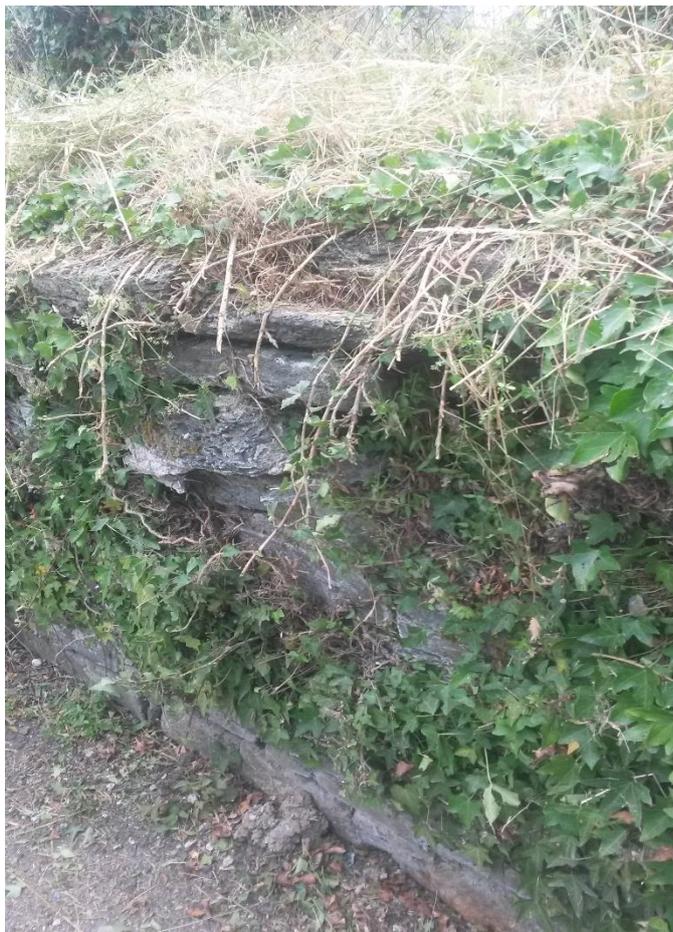
*'I stopped by last week and had a look. Clearly there has been movement and there is potential for structural failure in places but I am pleased that BCP have looked and given a view.'*

A site meeting was held by the Clerk and Peter Judd, a Building Surveyor, on 22<sup>nd</sup> July 2016 to ascertain costs for the monitoring of the wall for movement, a quotation is awaited and will hopefully be available for the meeting. It has also been advised that the ivy and vegetation is cut back and killed off rather than being pulled out of or off the wall as this could dislodge more stones and exacerbate the issues. Currently water is coming out through the wall between gaps in the stones and repointing with standard concrete would hold the water in, any repointing therefore should be done using a lime based mortar. It is hard to tell with the vegetation covering the wall but there are at least two areas, see photo of one specific area below as an example, which require coping stones to be removed and reset.

Following the advice from Building Control and in light of Graham Lawrence's comments, Mr Murrain has been contacted with a view to obtaining a quotation to remove the vegetation and re-bed loose stones, although the amount of work required will be difficult to establish until the vegetation has been cleared. The quote is awaited.
